INFRA RED SCANNING (THERMOGRAPHY) &

ULTRA SOUND

INFRA RED SCANNING (THERMOGRAPHY)

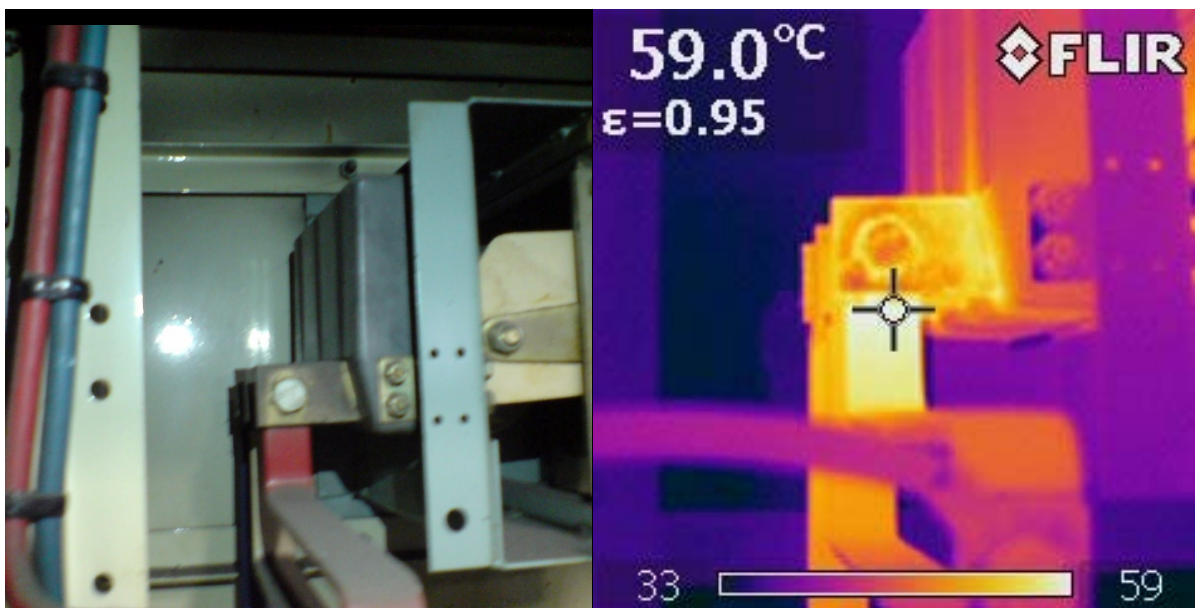
The Red phase supply of P36 MCC Isolator situated inside the Plant shows evidence of heat, the load is equal between phases. The Rph - 59°C, in relation to the other 2 phases. Need to be repaired as time permits, Class 2.
